RE: Centennial Train Track Maintenance – **Proposal #COC20220214A-1**

RE: Centennial Train Track Maintenance

RE: Inspection of Acme Park train bridge

City of Clinton, Acme Brick Park Train Bridge

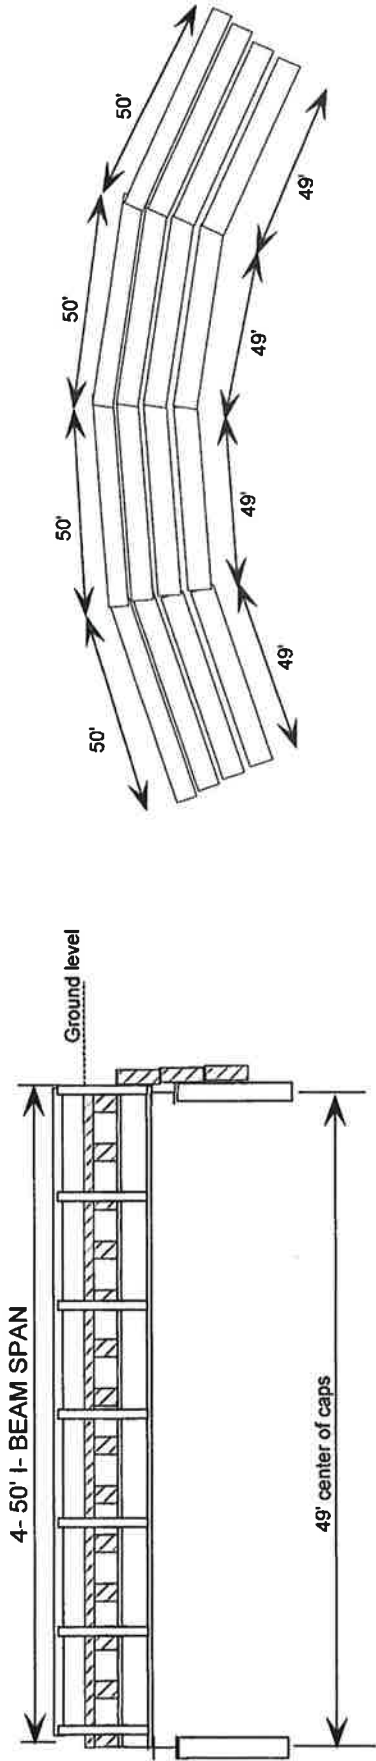
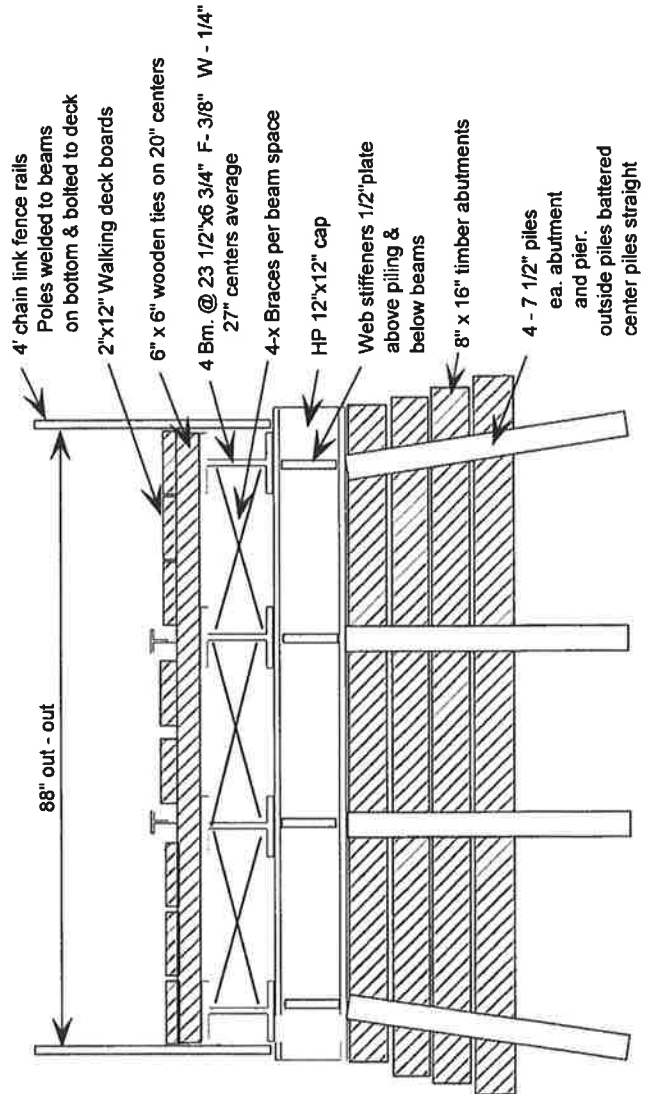
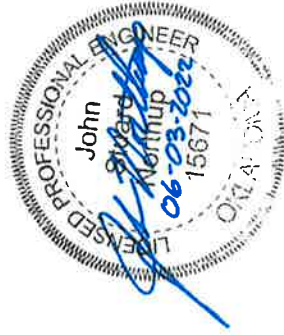
4 - 50' I - BEAM SPAN

Beams are straight and cut slightly shorter on each beam to make the arch in 4 spans. West beam = 50'. East beam = 49', Beams #2 = 49' 9". Beam #3 = 49'3. Beams spaced at different widths. Train tracks sit above beams #2 and 3 flanges for the most part. Over all out – out = 88", average spacing = 27"

X sway brace on bottom of beams is all still in place and working. Has several welds that were just tacked. 1 tack in #4 span (south) has broken on the outer edge of beam flange. Several others are just ½" short tack welds, but still good.

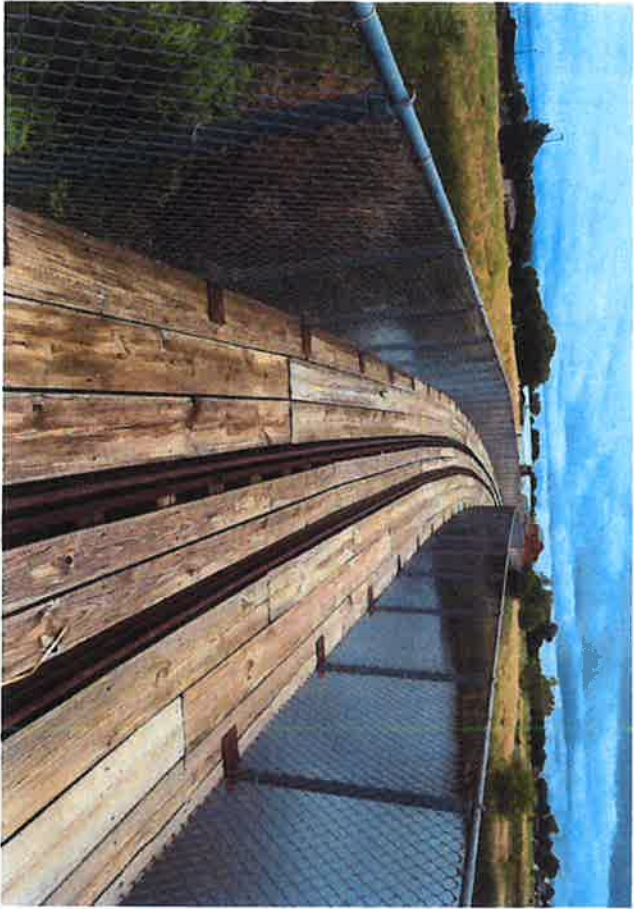
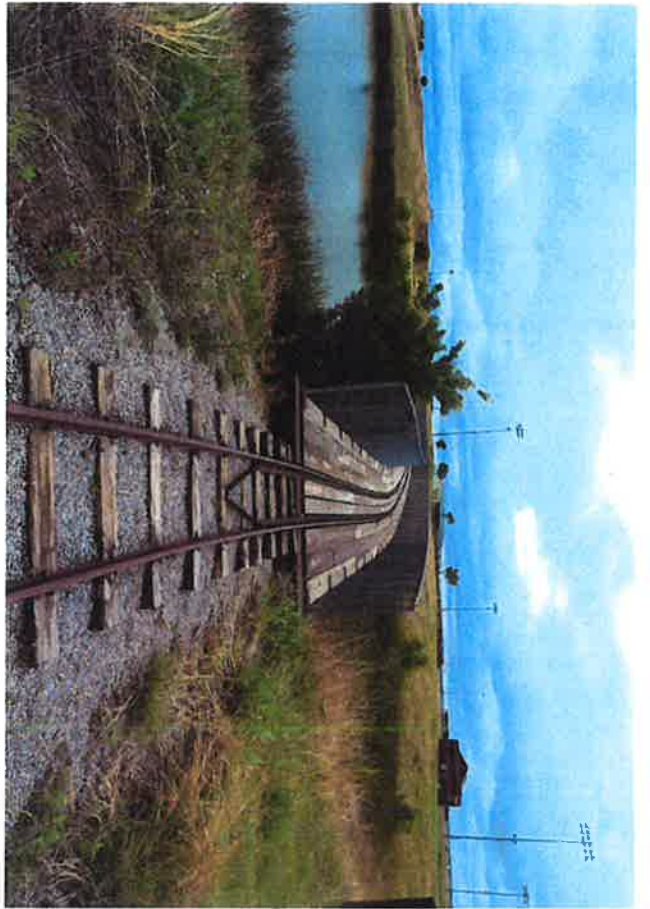
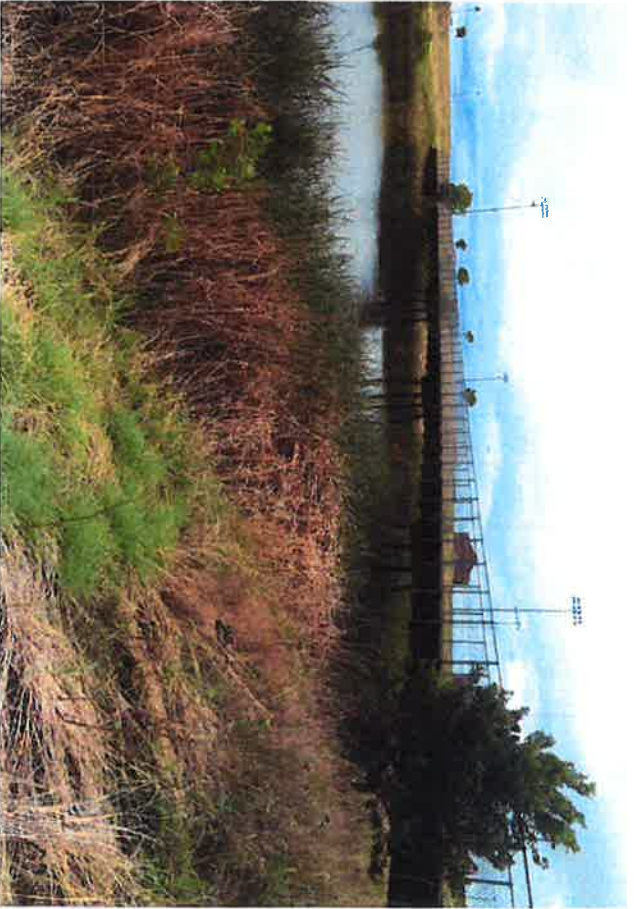
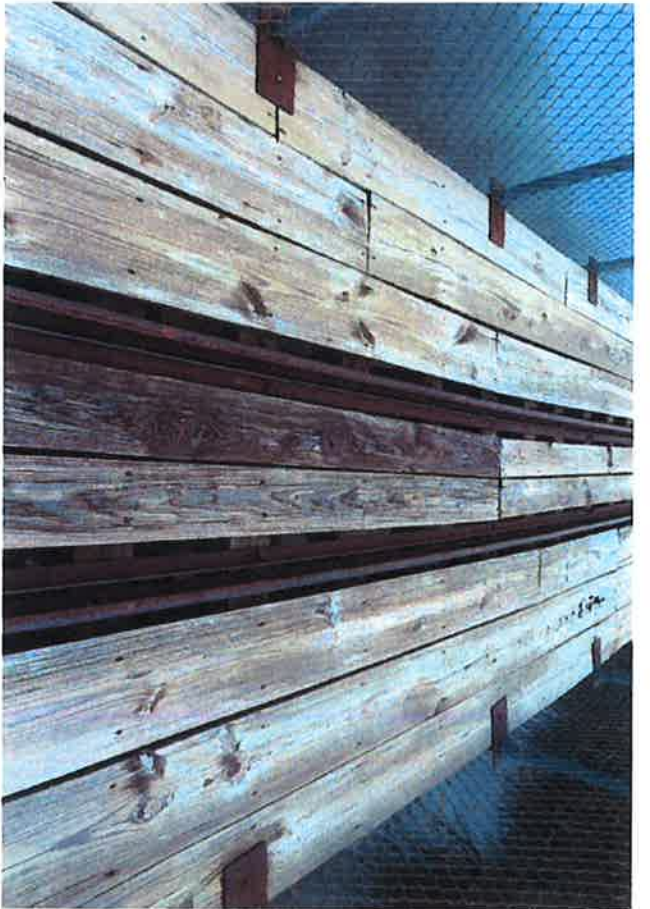
- The ties supporting the tracks are in very good condition, with little or no signs of wear or deterioration.
- The walking deck planks show normal minor weathering splits/checks, but not in sufficient amounts to be of concern. There is one plank between the rails at the East end of the bridge is partially broken and should be replaced.

SUPERSTRUCTURE: The superstructure is comprised of steel girders. They show no signs of deterioration, with the black paint system intact, with slight chalking in areas from sun exposure, and very little surface rust in some areas. There are steel plate cross sway braces welded diagonally across the bottom flanges of the steel girders. One of these welds has broken loose from the girder on the South beam, East span. While not of major concern, this should be re-welded in the near future by a certified welder.

The piers were visually inspected down to the ground line/water line. All of the substructure members appear to be in good condition, with no issues other than some minor surface rusting where the abutment/pier members meet the soil and where the piers over water meet the water line/splash zone. None of this surface rusting is of concern at this time, but should be periodically monitored (every two years would be sufficient) to make sure rusting doesn't progress to the point that the members are reduced in load carrying capacity.

1. Replace the broken timber plank between the rails on the East end of the deck to avoid a potential pedestrian being injured by it.
2. Re-weld the broken weld of the sway brace noted earlier.
3. Monitor the pier columns in the water/splash zone periodically to insure the rusting there doesn't progress to where enough section of pipe pile is rusted away to negatively affect the load capacity of the members.
